# Manhole Inspection Summary

Manhole # S41CC\_037MH

Insp Date: **8/31/09 3:01 PM**

**Location** Address: **1409 EAGER ST**

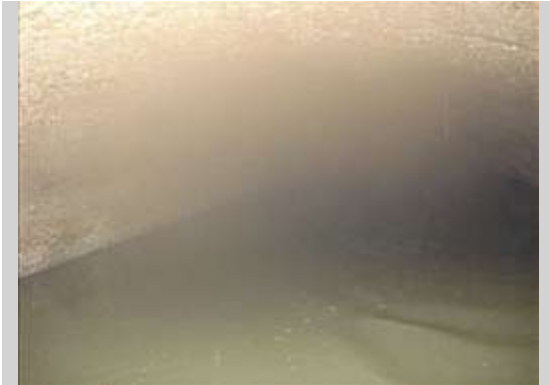
12 O'Clock Outflow

72 in. Circular Gravity Sewer  
Pipe Out @ 12 O'Clock

Pipe Height: (in.) Direct  
Pipe Material: **Concrete** ☐ Pipe Lined  
Invert Depth: **32.30** (ft.) Flow Characteristics: **Fast**  
Deposits: ☒ None ☐ Mud ☐ Sludge ☐ Debris ☐ Grease  
Silt Depth: (in.) Deposits Extent:  
Infiltration: **None** Pipe Seal Cond: **Sound**
